# BEAR LAKE COUNTY AIRPORT (PARIS)

This report describes how your pavement maintenance management program was developed. This program was developed as part of the Network Pavement Management Program project sponsored by the Idaho Transportation Department, Division of Aeronautics. The information and data contained in this report ensures you are in compliance with the requirements of Federal Aviation Administration (FAA) Grant Assurance Number 11 which states that any airport requesting federal funds for pavement improvement projects must have implemented a pavement maintenance management program (PMMP).

Using the branch, section and sample unit divisions established, a visual condition survey was conducted at Bear Lake County Airport (Paris) on November 04, 2006. During the inspection pavement defects were identified and measured in accordance with the methodology outlined in FAA AC:150/5380-6 and ASTM D5430. Our inspection ensures your airport complies with the “detailed inspection” requirement of FAA’s PMMP guidelines. After collection, the data were entered into the Micro PAVER software for analysis. These data are reproduced in the Re-Inspection Report attached in Appendix 2

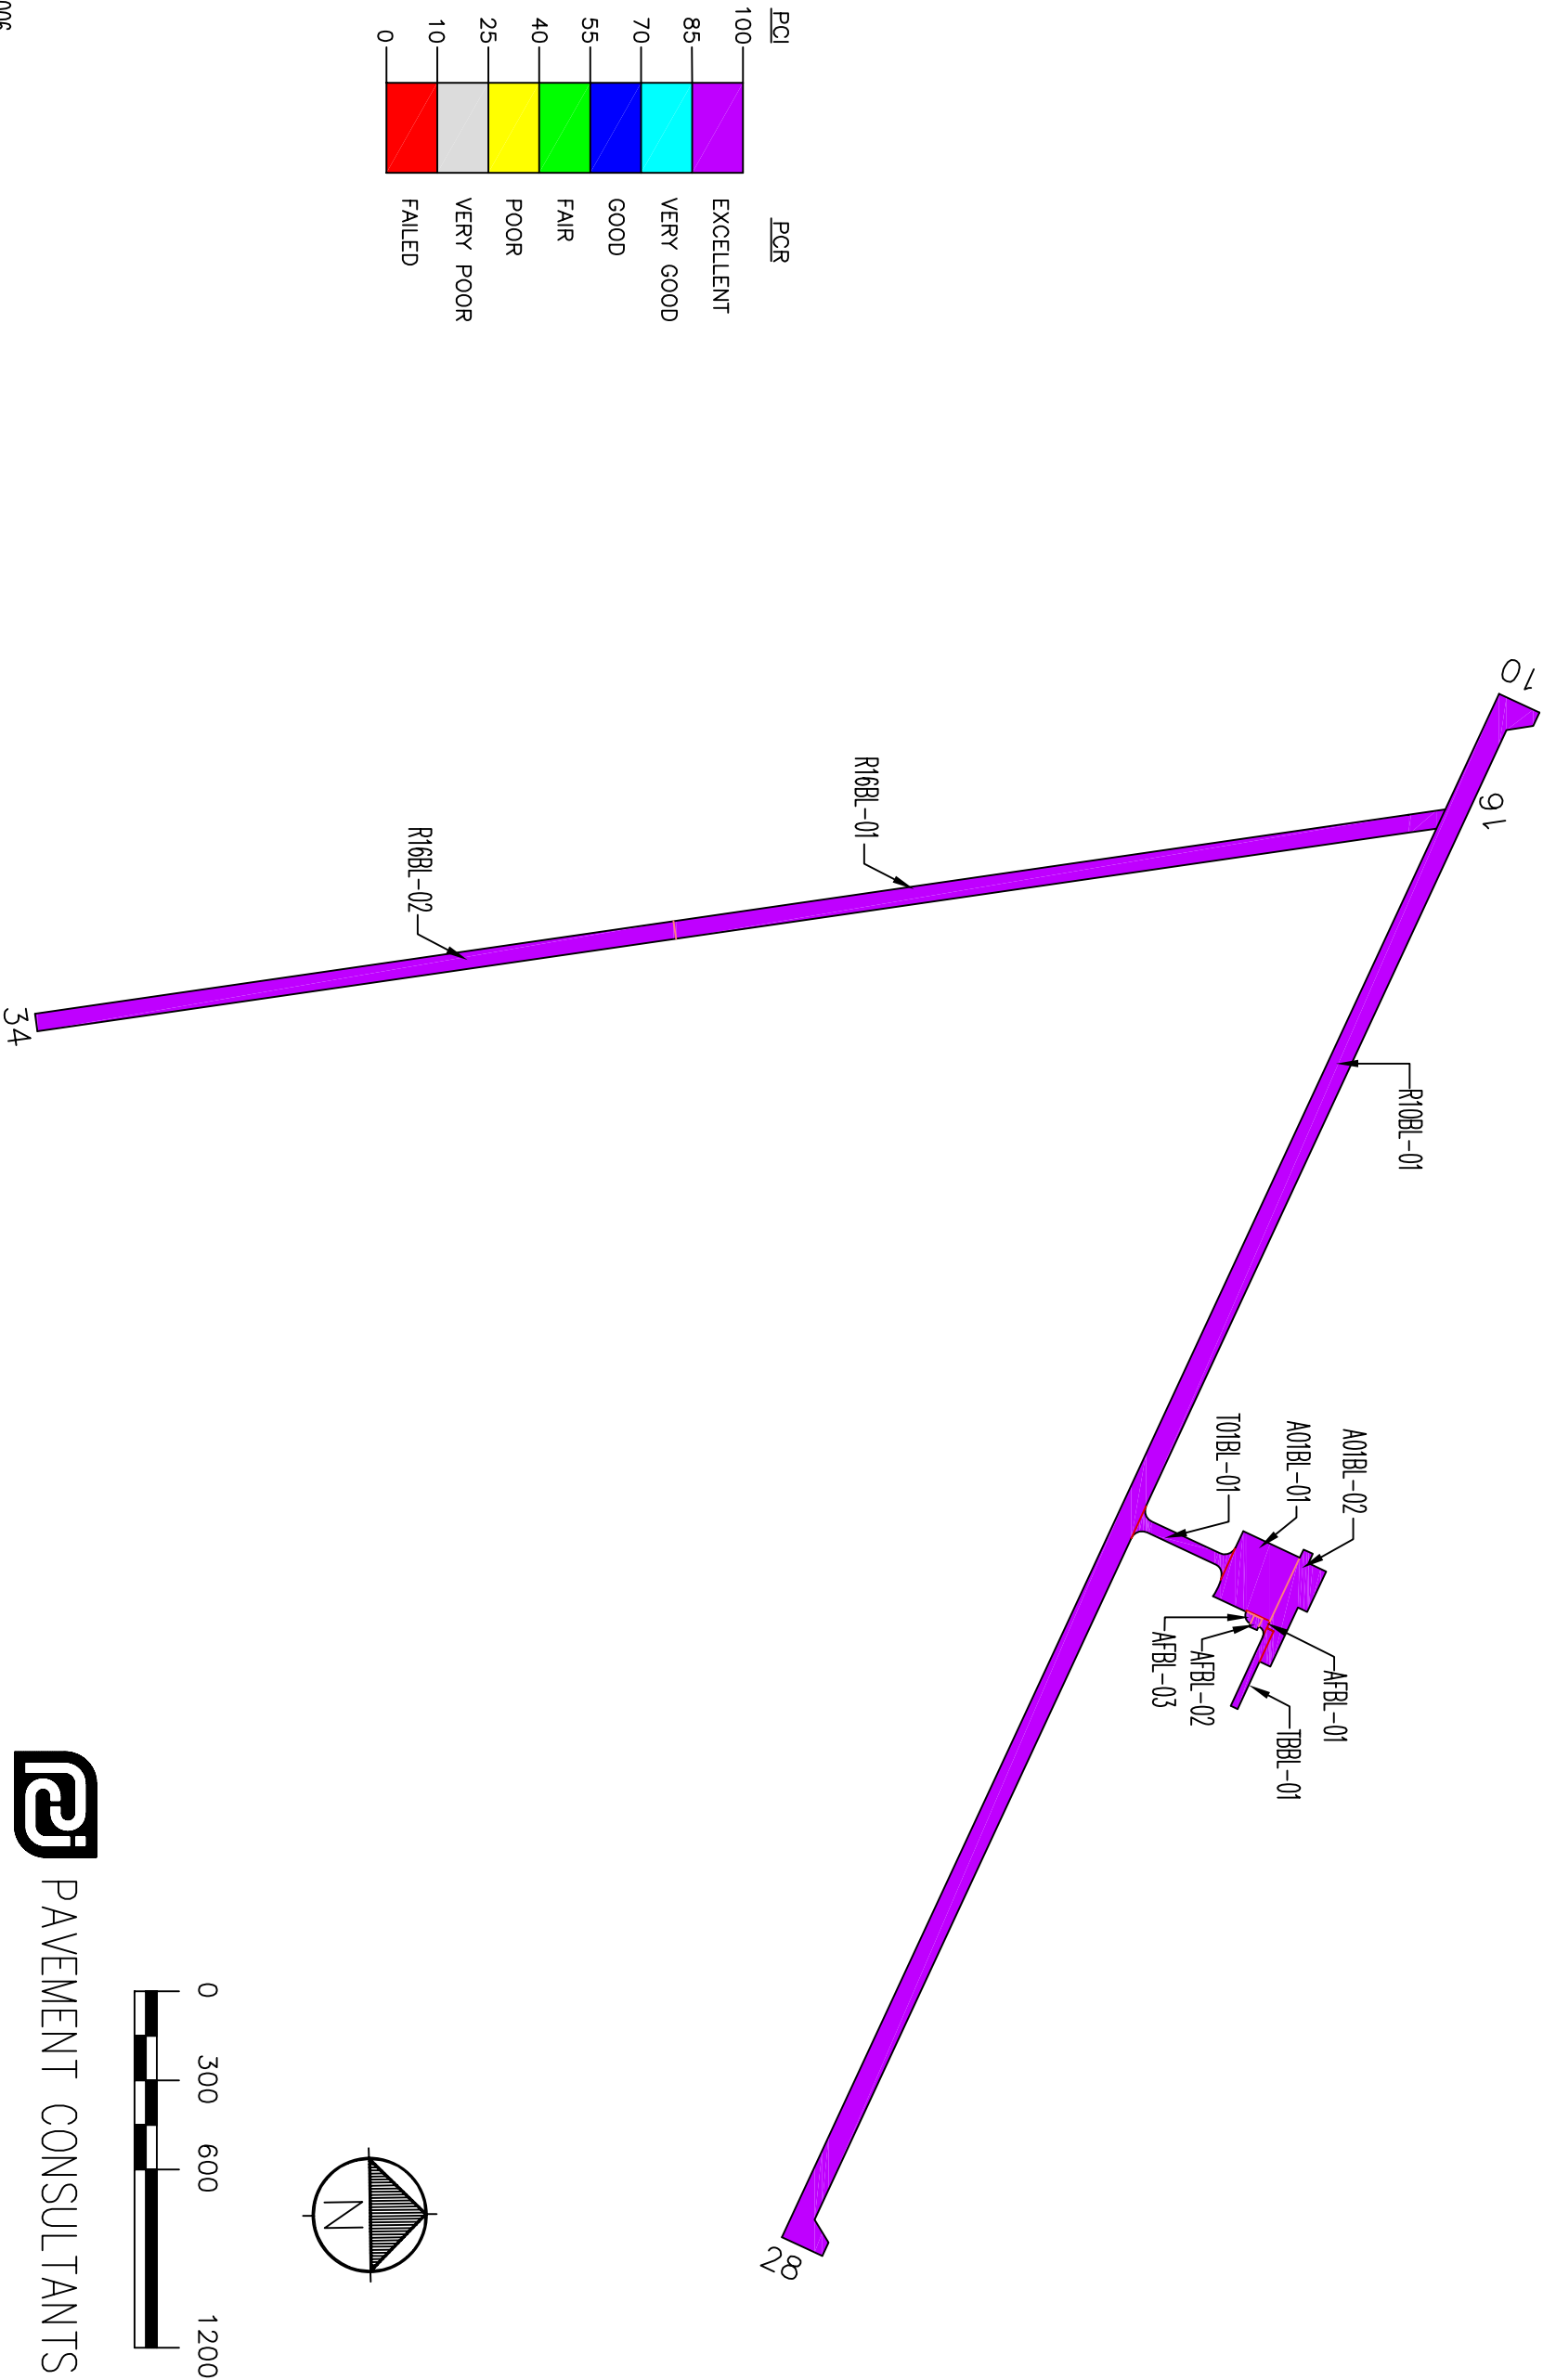
Figure BL-3. Pavement Condition in 2006.  
Bear Lake County Airport (Paris)

Using the data collected during the visual inspection, the Micro PAVER software calculated a Pavement Condition Index (PCI) for each pavement section inspected by averaging the PCIs for inspected sample units. Using each section's PCI, a Pavement Condition Rating (PCR) was assigned. The PCIs and associated PCRs from this inspection are shown in Table BL-2. This table also contains projected PCIs for 2011 and 2016 based on pavement deterioration models developed by Micro PAVER using the inspection data from pavements in Idaho having the same surface types. The Branch Condition Report in Appendix 2 summarizes current pavement condition by branch while the Section Condition Report in Appendix 2 lists pavement condition by section. The current PCR is shown graphically in Figure BL-3.

Section PCIs at the airport range from a low of 91 (a PCR of "Excellent") to a high of 100 (a PCR of "Excellent"). The area-weighted average PCI for all airport pavements is 93, corresponding to an overall PCR of "Excellent". Figure BL-4 shows how much pavement area is associated with each Pavement Condition Rating category and also shows pavement condition distribution from the inspections conducted in 1996 and 1999. A graphical representation of the projected PCRs presented in Table BL-2 is shown in Figure BL-5.

The primary distresses observed during the inspection were longitudinal and transverse cracking, and weathering/raveling with isolated occurrences of slippage cracking and oil spillage.
